**PALMETTO HALL
RECYCLED WATER PROJECT
Hilton Head Public Service District
Hilton Head Island, South Carolina**

2016-2017 BIENNIAL BIOLOGICAL MONITORING REPORT

**Boulder, Colorado
March, 2018**

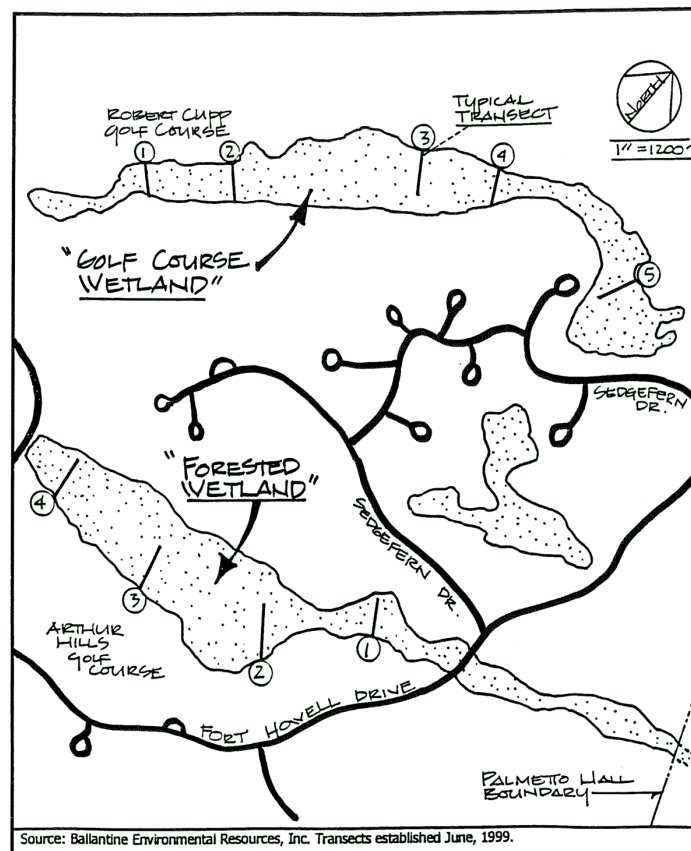
2-3. Golf Course Wetland

Sheet-flow drains in an eastward direction through the wetland, then through downstream off-site wetlands, on its way to Port Royal Sound (Figure 2-3).

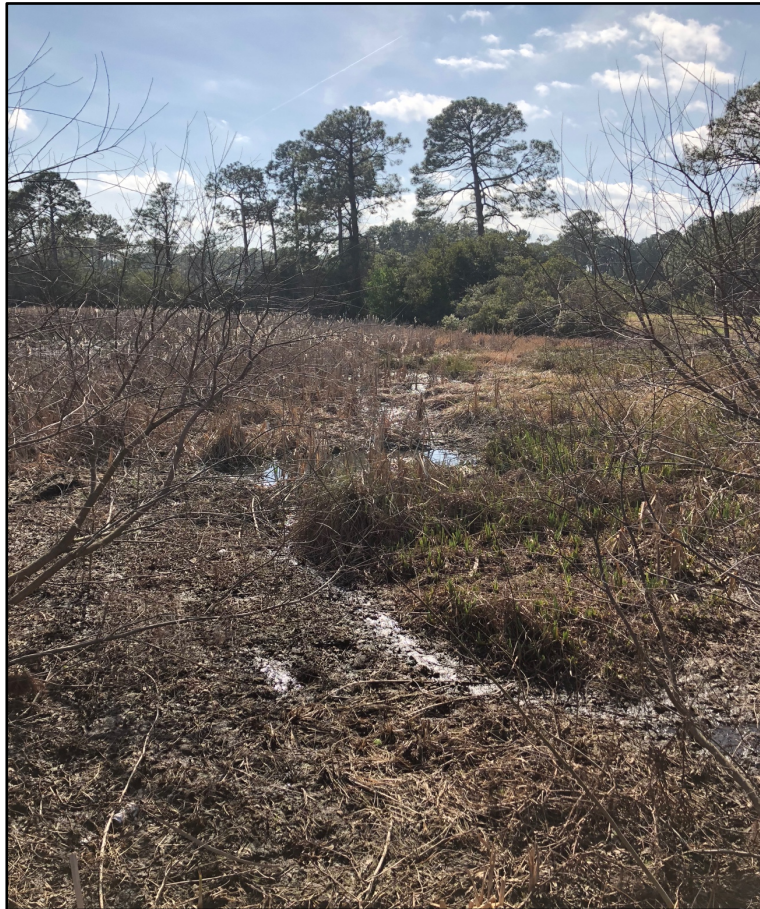
The Forest shrub and groundcover suffered very little damage due to the protective nature of the dominant hardwood trees. This community is highly resilient. The Golf Course wetland was exposed to wind and water depredation. The primary example of the impact was flooding and sedimentation in the former sawgrass marsh which declined substantially by storm flooding and sedimentation.

Dieback of the Salt Marsh Community in the Golf Course Wetland.

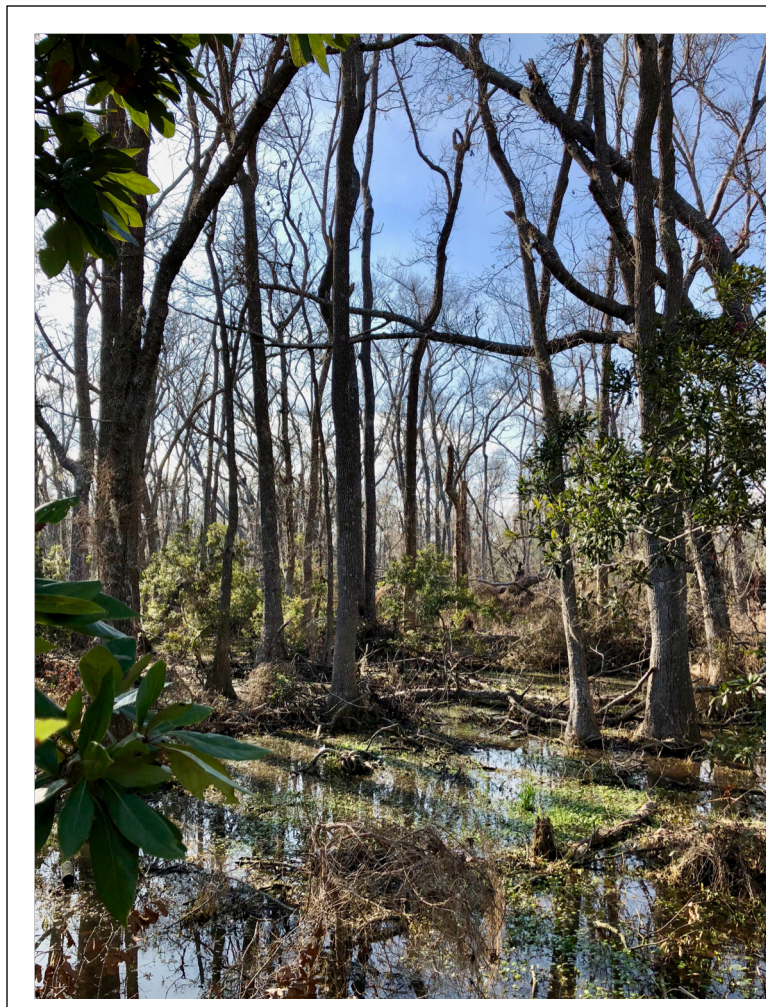
Sturdy swamp blackgums in The Forest Wetland
